Manhole Inspection Summary

Manhole # S27C__041MH

Location Address: **914 SARAH ANN ST**

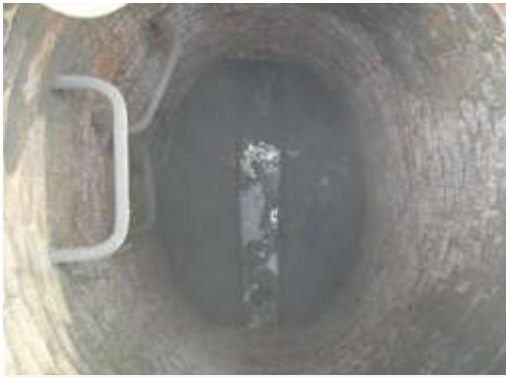
Top View

Frame Offset: **0** (in.) Condition: ☐ Sound ☒ **Cracked** ☐ Leaks

Condition: ☐ Sound ☒ **Cracked** ☐ Root Intrusion ☒ **Loose Brick** ☒ **Deteriorated**
